## A guide to the use of 3CR12 in water – 2<sup>nd</sup> edition

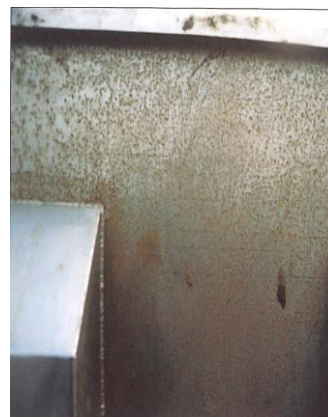
Mild steel contamination on 3CR12

- 3CR12 should be handled in the same way as stainless steel, with every effort being made to ensure cleanliness both in the workshop and on-site. **Contamination from mild steel can cause significant discolouration and potential loss of corrosion resistance.**

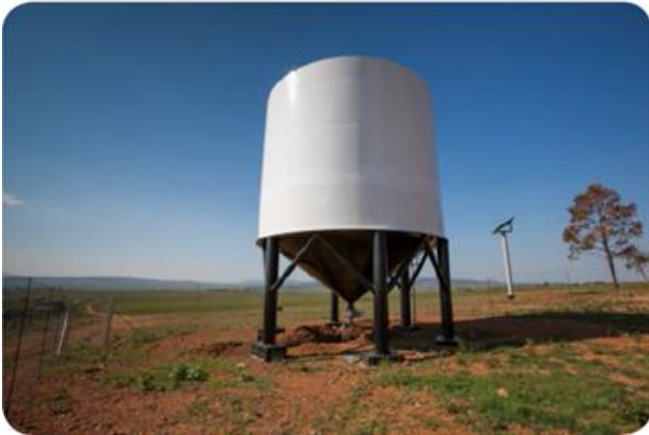
*Municipal water tank manufactured from 3CR12 instead of concrete; the manufacturer won an award from SASSDA*

The most recent application of 3CR12 was in the fabrication of municipal water storage tanks. Traditionally these water storage tanks were fabricated from concrete, which necessitated extensive cleaning operations to ensure adequate water quality for human consumption due to settling of silt in the water. The manufacturer provided a tender submission which recommended 3CR12 as the basis for a new water storage tank design, as well as proper drainage design to lower the maintenance requirements on the water storage tank. The tender was awarded to the manufacturer, where after SASSDA awarded them with a prize for their innovative design. The manufacturer was nominated as a contestant in the International Stainless Steel Federation awards.

Photograph shown earlier in the document as an example of proper tank design.

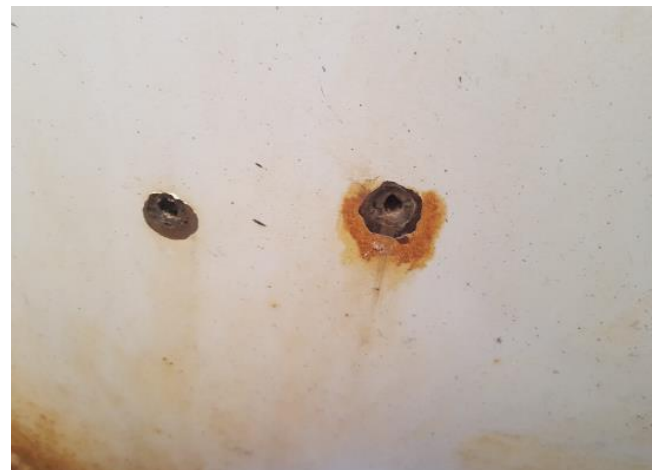
*Microbial induced corrosion on the internal surface of a water tanker lead to concentration of deleterious chlorides causing pitting corrosion due to poor water chemistry*

Sulphate reducing bacteria (SRB), and iron oxidising bacteria have been cited as the most common causes of MIC in 3CR12. SRB associated corrosion occurs in anaerobic conditions in the presence of water, and is affected by flow rates - beyond a certain flow rate bio fouling ceases. The mode of attack is pitting rather than general corrosion. MIC caused by SRB therefore perforate a pipeline rather than disintegrating the line.

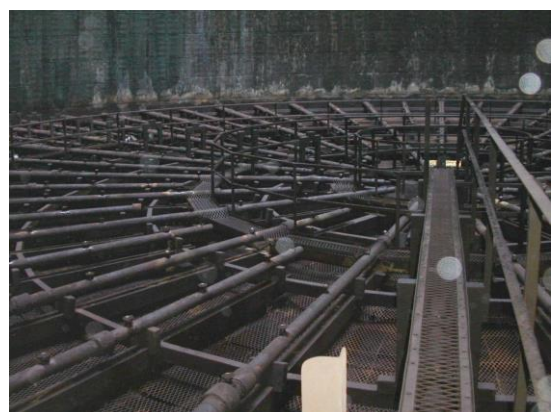
View of the X-GRID layers inside the cooling tower after 20 years' service. Diameter is approx. 52 metres. Picture courtesy of SASSDA.

X-GRID, an expanded metal mesh manufactured from 3CR12, has been installed in several cooling towers over the past few years. The longest service installation has been in use since December 1986. During that time these towers have been in full operation, with the exception of periods in which electricity demand was low and the station may have taken a tower off-line. The power station is still in operation, hence a service life of about 30 years for the X-GRID installation. The X-GRID is exposed to circulating purified sewage effluent. Typical water-quality values of the circulating water are: pH 7.3- 9.3, chloride 90-160 ppm, sulphate 100-150 ppm, and nitrate 40-70 ppm. Circulating water is distributed above the cooling pack below. Droplets of water impinge on the splash bars of the X-GRID, causing smaller droplets to fall to the next layer below. Therefore, although the X-GRID is not immersed in water, its surface is totally wetted at all times during operation. The incoming and outgoing water temperatures vary with the ambient conditions, but are of the order of 35-40°C and 25-30°C respectively.

Under these conditions 3CR12 exhibits generally good corrosion resistance, with no definite signs of general or localized corrosion. Minor discolouration was caused by mild steel contamination during the manufacture of X-GRID.

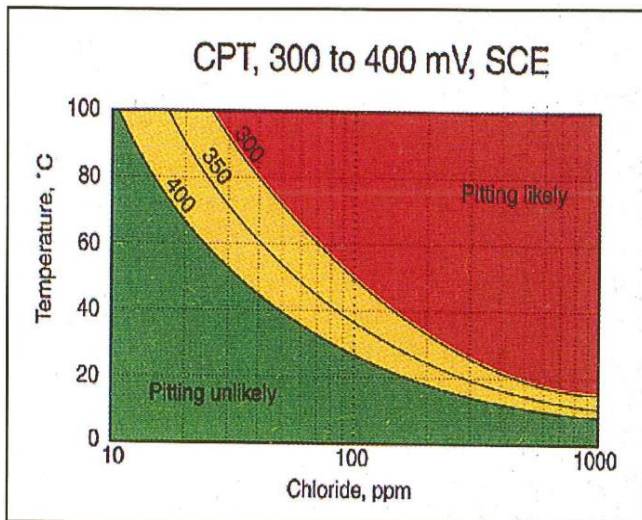
CPT diagram for 3CR12

Chloride ions have a detrimental effect on the localized corrosion of stainless steels by enhancing the localized dissolution of the thin passive layer. Increasing chloride ion concentration and temperature reduce the localized corrosion resistance of the material. Critical pitting temperature diagrams (CPT) are often produced

in order to ascertain the propensity of the material to pitting attack. These diagrams are produced for waters containing chlorides only. The CPT diagram for 3CR12 is shown. In waters where other ionic species are present, caution should be exercised in taking a particular numerical value for pitting potential.

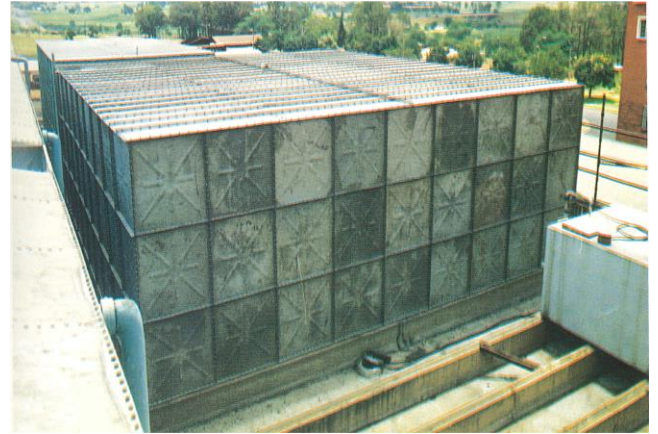
*Boiler feed water storage tank installed at Rooiwal Power Station*

3CR12 found application in construction of a water storage tank for demineralized water (boiler feed water) at a power station as pictured below. It was constructed of rectangular panels, screwed together. This invariably means that a crevice is created between the mating surfaces of the panels; however this was overcome by sealing the crevices as shown in the second photograph. The water tank was installed in 1984, although the power station operates at lower than design output currently.
